# Manhole Inspection Summary

Manhole # S13S\_\_008MH

**Location** Address: **1021 Parksley St**

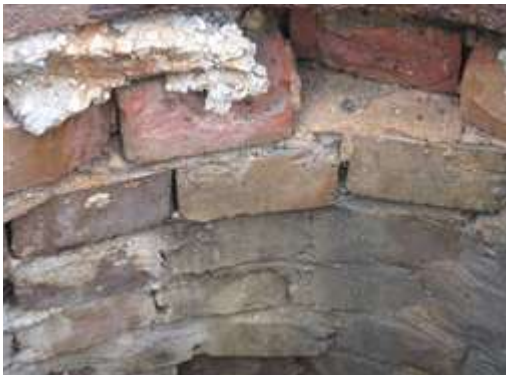
Defect 3

loose bricks and mortar under frame

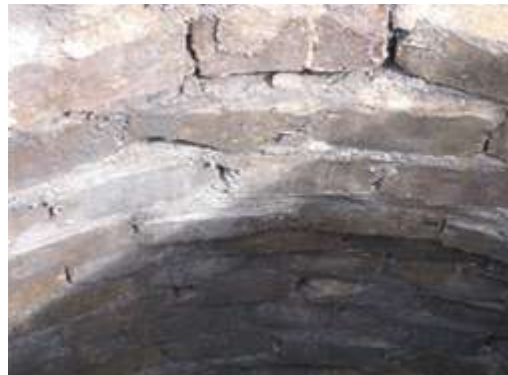
Defect 2

loose bricks and mortar in chimney,  
infiltration

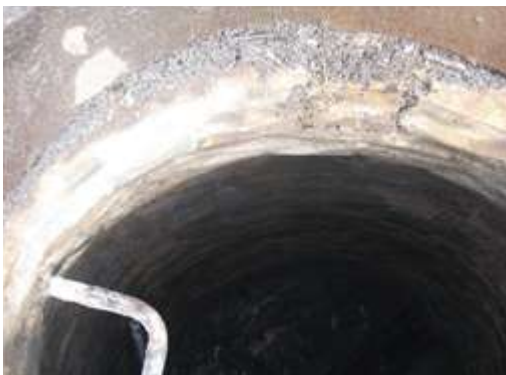
Defect 1

Frame leaks and chimney loose bricks

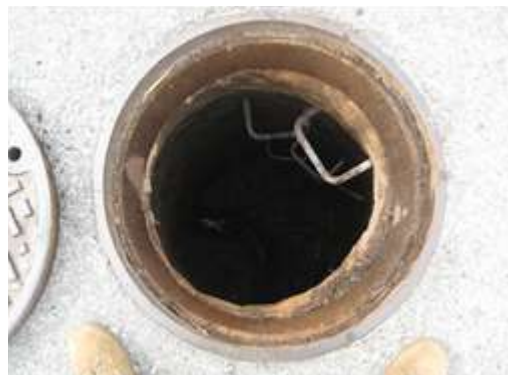
Defect

**Frame** Offset: **2.5** (in.) Condition: ☒ Sound ☐ Cracked ☐ Leaks

Frame offset 2.5

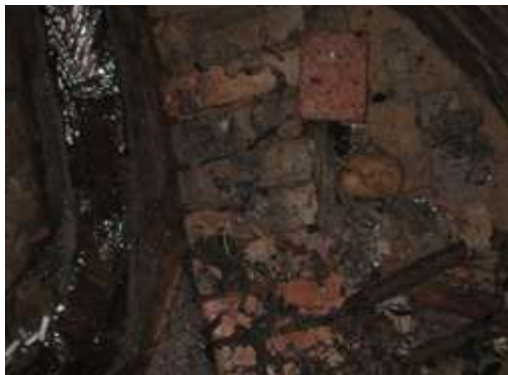
### Defect 4

Condition: ☐ Sound ☐ Cracked ☐ Root Intrusion ☐ Deteriorated ☐ Leaks ☒ **Debris**

debris on bench

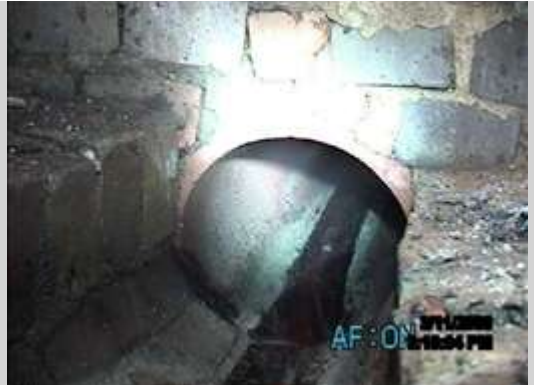
12 O'Clock Outflow

Pipe Height: **7.2** (in.) Rod and Bar (Angled)  
Pipe Material: **Clay** ☐ Pipe Lined  
Invert Depth: **10.86** (ft.) Flow Characteristics: **Slow**  
Deposits: ☒ None ☐ Mud ☐ Sludge ☐ Debris ☐ Grease  
Silt Depth: **0** (in.) Deposits Extent:  
Infiltration: **None** Pipe Seal Cond: **Sound**

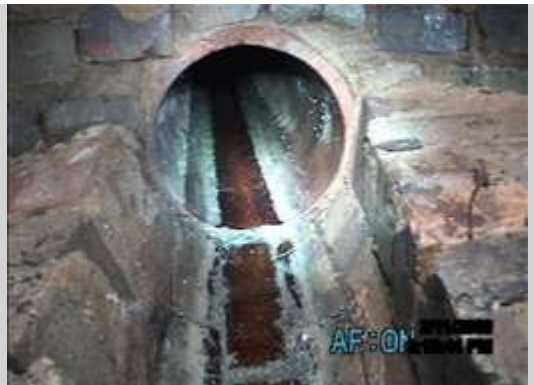
3 O'Clock Inflow

Pipe Height: **8.4** (in.) Rod and Bar (Angled)  
Pipe Material: **Clay** ☐ Pipe Lined  
Invert Depth: **10.16** (ft.) Flow Characteristics: **Slow**  
Deposits: ☒ None ☐ Mud ☐ Sludge ☐ Debris ☐ Grease  
Silt Depth: **0** (in.) Deposits Extent:  
Infiltration: **None** Pipe Seal Cond: **Sound**
